**AIRCRAFT GROUND-FLOTATION INVESTIGATION
PART VI DATA REPORT ON TEST SECTION 3**

**TECHNICAL REPORT AFFDL-TR-66-43, PART VI
AUGUST 1966**

PART VI DATA REPORT ON TEST SECTION 5

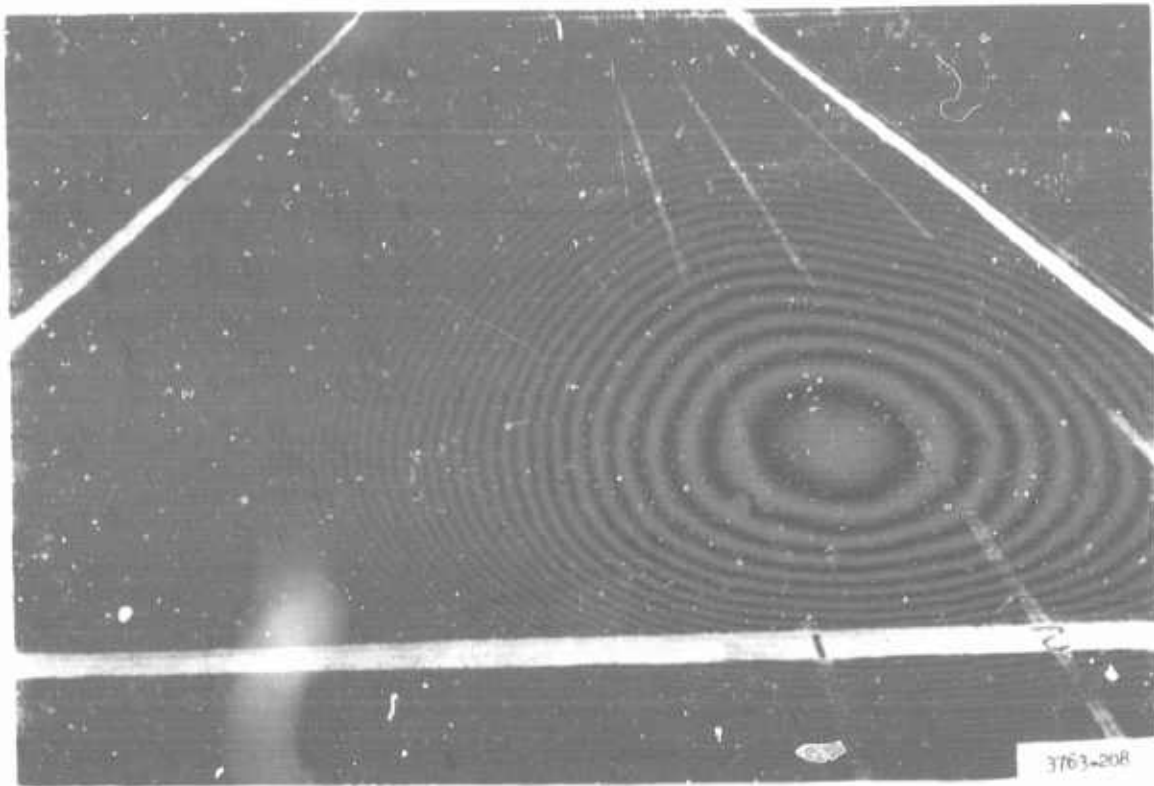
Figure 4. Lane 9, item 1, prior to traffic

Item 1. Figure 4 shows item 1 prior to traffic. Mat breaks first became apparent at about 45 coverages; differential deformations developed slowly, averaging less than 1 in. for each of the three straightedge positions at 90 coverages. At 109 coverages, mat runs 16 through 19 at the transition between item 1 and the previously failed item 2 were removed for subgrade repairs. After repairs and replacement of mat panels, traffic was continued. The item was considered failed due to roughness at 199 coverages (figures 5 and 6). The rated CBR was 2.4.

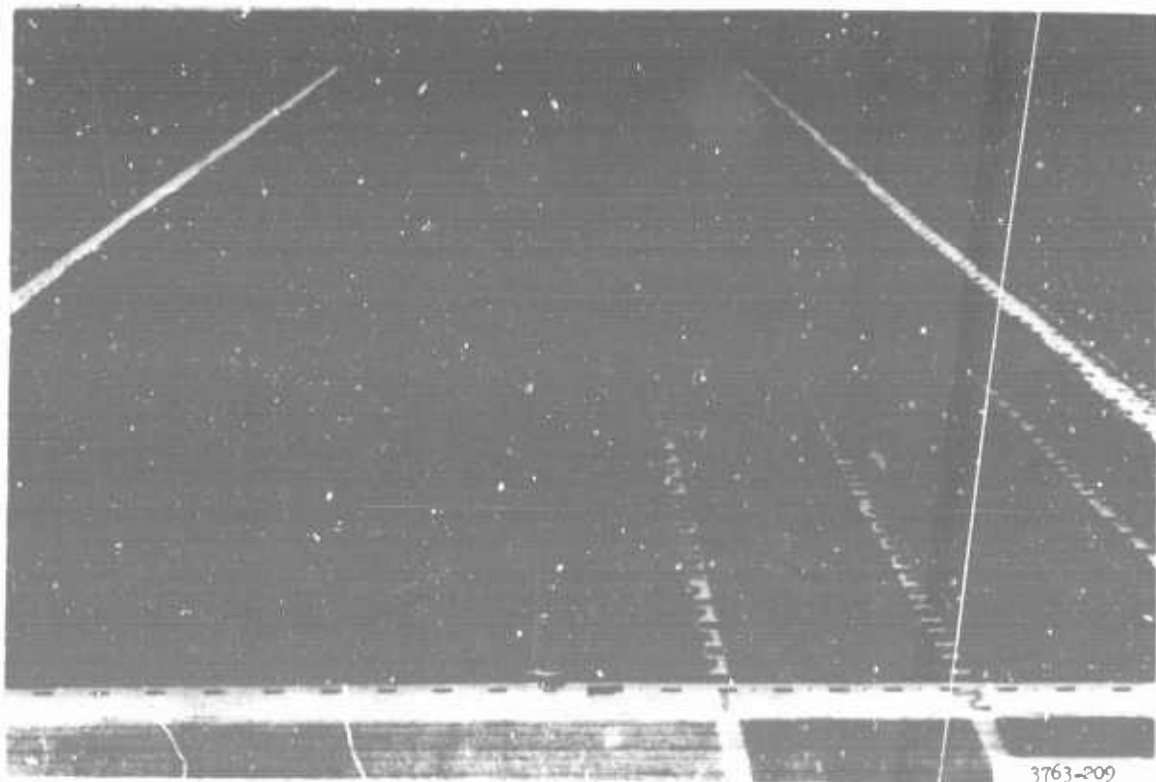
Figure 7. Lane 9, item 2, prior to traffic

Item 2. Figure 7 shows item 2 prior to traffic. By 20 coverages average differential deformations generally exceeded 1 in. on the item surface. It was observed during trafficking that at each pass of the load vehicle when the longitudinal mat-joint line was straddled by two load wheels, the overlapping ends of the planks at the joint would protrude upward. However, when a load wheel passed directly over the joint line, the plank ends were pressed flat again. Thus, the worst condition of mat roughness occurred when the former situation existed. The item was considered failed due to roughness at 102 coverages (figures 8 and 9). The rated CBR was 4.1.

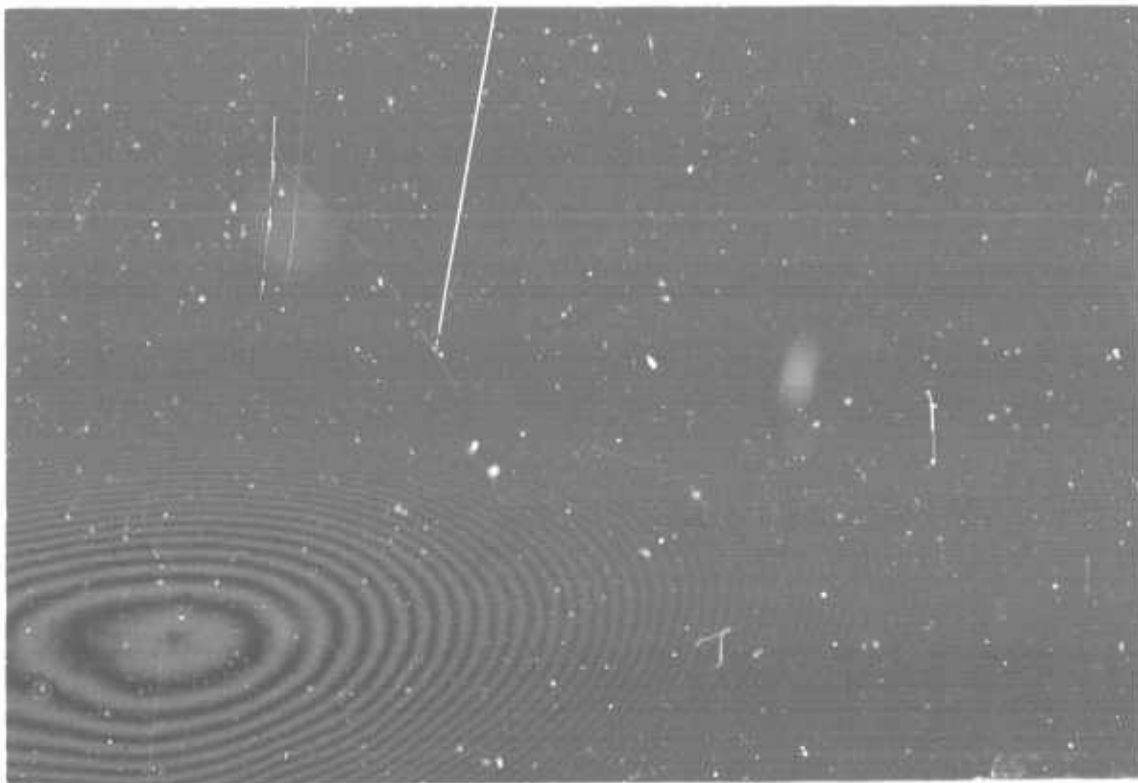
Figure 10. Lane 9, item 3, prior to traffic

Item 3. Figure 10 shows item 3 prior to traffic. The soil surface rutted easily and the item was considered failed due to rutting at 20 coverages (figure 11). The rated CBR was 9.8.

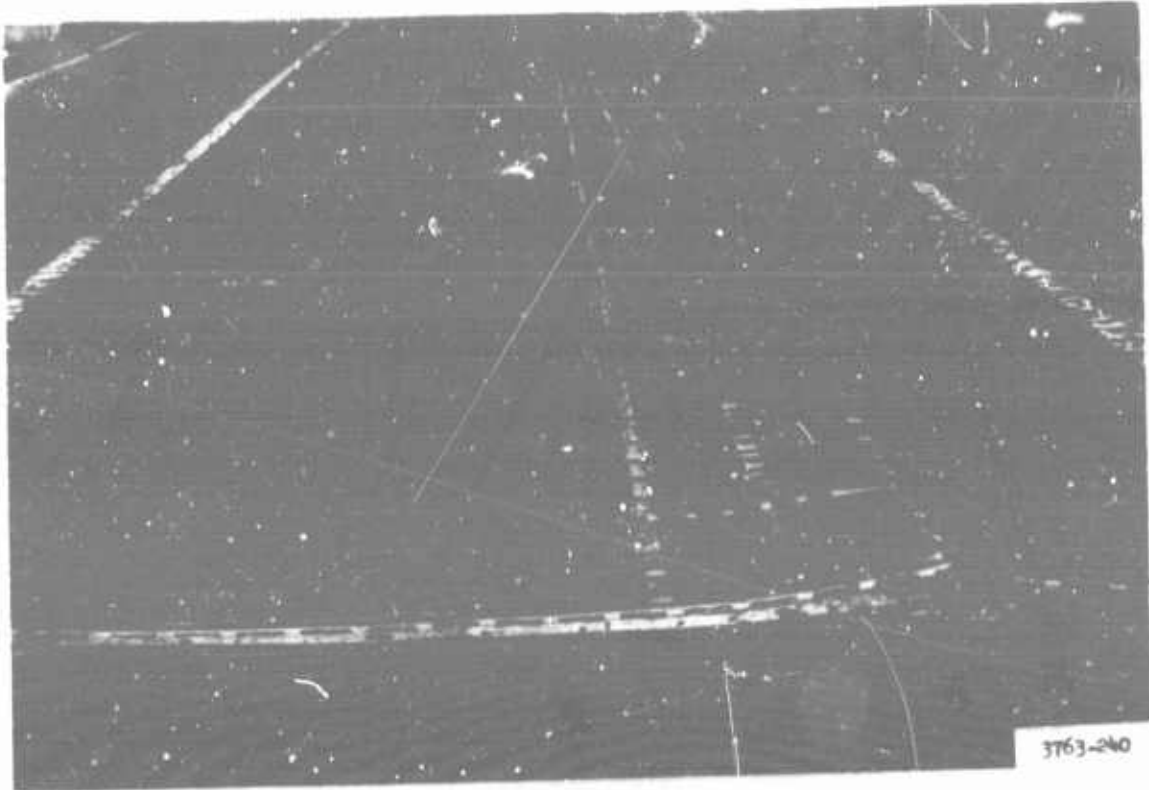
Figure 18. Lane 10, item 3, prior to traffic

Item 3. Figure 18 shows item 3 prior to traffic. The surface deformed easily under traffic and the item was considered failed due to rutting at 24 coverages (figure 19). The rated CBR of the item was 9.8.

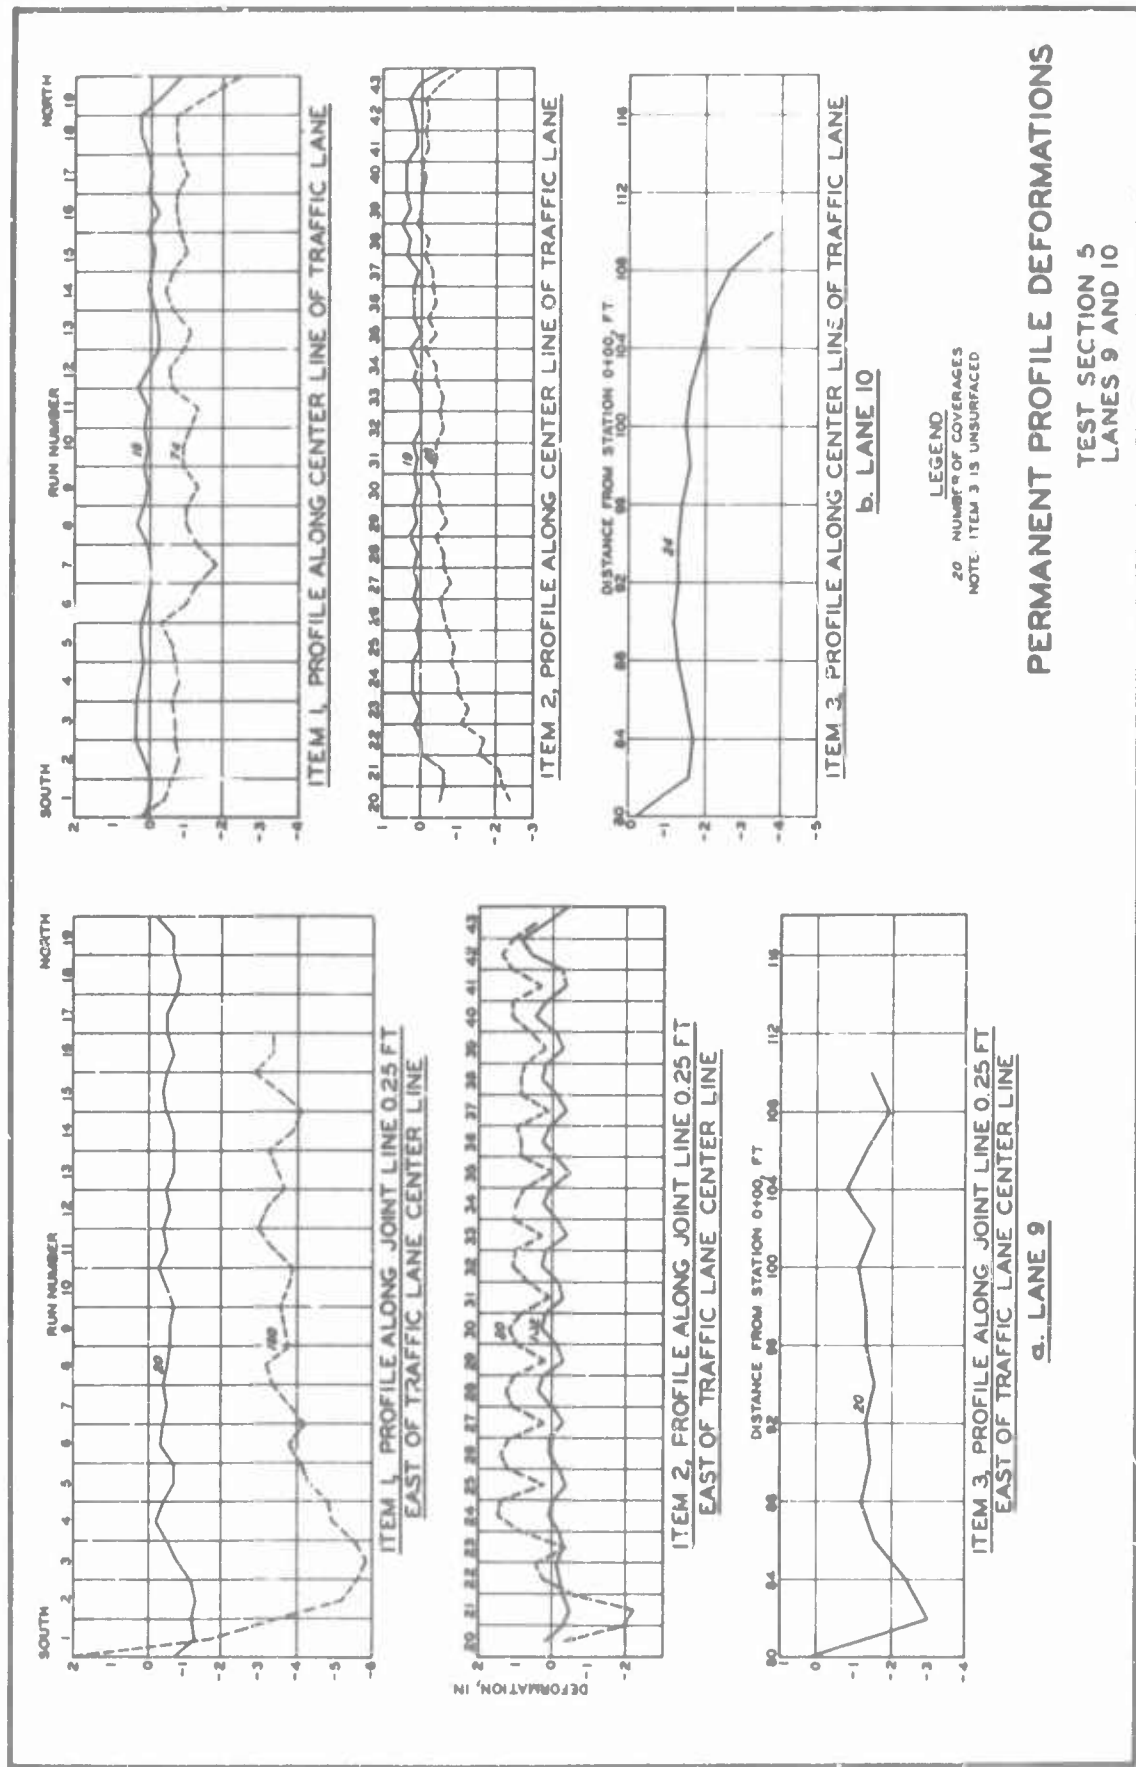
- b. Deformation. Figures 23 and 24, respectively, show average cross-section and profile plots for 20 and 199 coverages. Cross-section measurements for both typical mat runs are shown in figure 23. The deformation plots illustrate the subsidence and troughing effect that existed at failure of the item.

- b. Deformation. Average cross-section plots at 20 and 102 coverages are shown in figure 23 for the two typical mat runs. At failure the center-line surface elevation was higher in both plots than prior to trafficking. A profile along the mat-joint line, 0.25 ft east of the lane center line, is shown in figure 24. The elevation of the mat ends caused when two wheels straddled the mat-joint line is evident at the 20- and 102-coverage levels represented.

- b. Deformation. For each of the two typical mat runs, figure 23 shows average cross-section deformations at 19 and 74 coverages. Shown in figure 24 is a profile along the lane center line representing the same coverage levels.

- b. Deformation. Average cross-section deformations at 19 and 48 coverages for each of the two typical mat runs are plotted in figure 23. Figure 24 shows a center-line profile representing the same coverage levels. The cross-section plots emphasize the characteristic high point that developed at the mat end joints located within the traffic lane.
